Unrecognised perforation of the uterus into bladder by an IUD

Uterine perforation and laparoscopic retrieval of a levonorgestrel intrauterine system (Mirena[®])

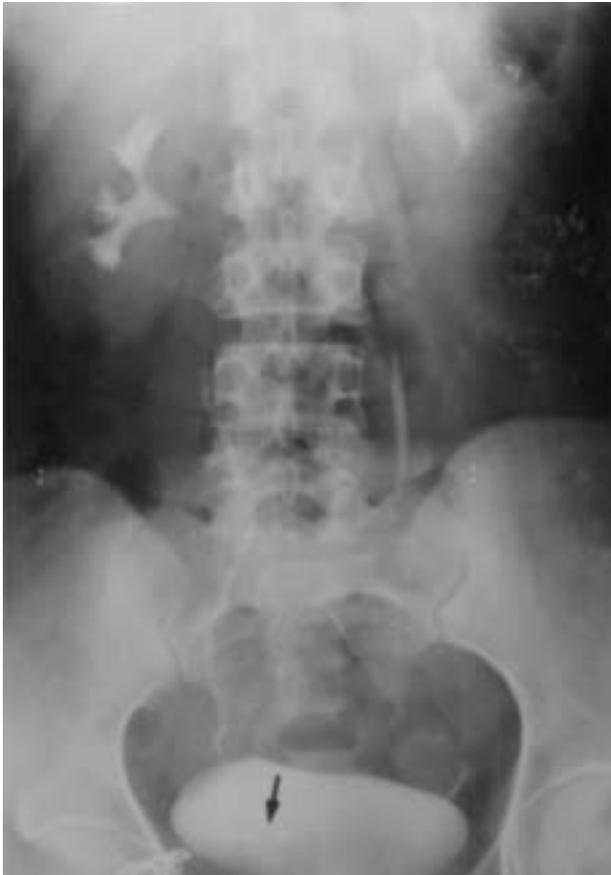
Figure 1. IVP demonstrating an IUD in the right side of the pelvis or bladder.

The patient was advised to continue with her pregnancy. The pregnancy and delivery were uncomplicated. After that time she frequently developed urinary infections. Urinalysis showed numerous red and white blood cells but other laboratory findings were normal. Intravenous pyelography revealed an IUD in the pelvis (Figure 1). Because there was a history of IUD insertion without confirmation of expulsion, pelvic sonography was performed to confirm the site of the device. An IUD (copper T) was seen to the right of the bladder surrounded by a hypoechoic and ovoid image at the end of IUD. This image resembled the tail of an IUD (Figure 2). Changing the patient's position did not alter the position of the device in relation to the bladder. The reason proved to be adhesion formation. These findings were confirmed by cystoscopy.

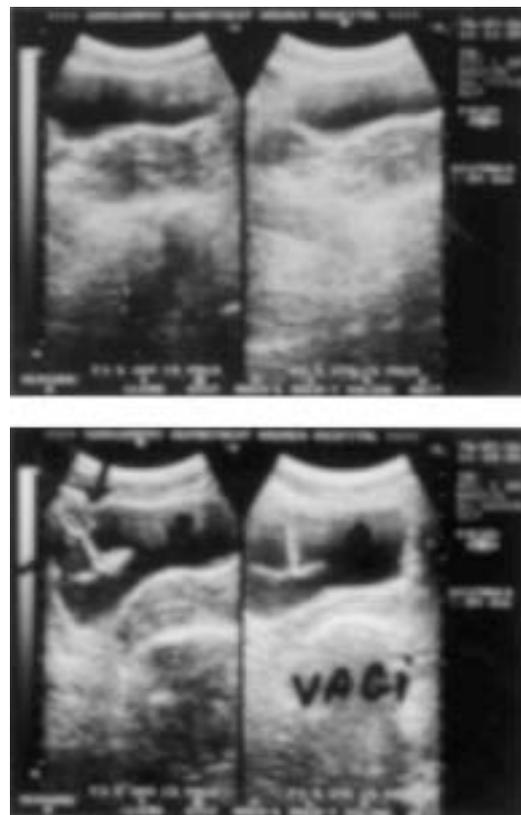
Figure 2. Pelvic ultrasonography confirmed an IUD in the right side of the bladder.
